MAD RIVER DAM & RESERVOIR

MAD RIVER, CONNECTICUT

DESIGN MEMORANDUM NO. 2

SITE GEOLOGY

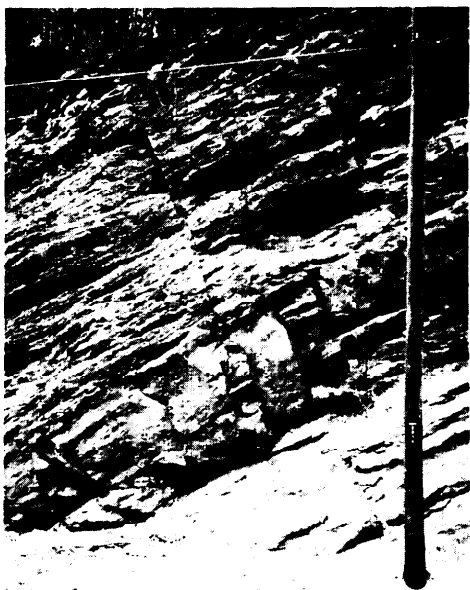
FIGURE 1

TYPICAL BEDROCK EXPOSED IN HIGHWAY CUT

MAD RIVER DAM SITE

mainly a series of closely folded, crumpled and highly jointed metamorphic rocks intruded locally by large masses of granitic rocks. As shown in photographs of typical bedrock exposed in the highway cut at the site, Figure 1, both the rock type and structure vary widely within short distances. In spite of the local variations, however, there is a very general north-south trend to the bedrock structural lineation at the site. On the left abutment, in the spillway area, and along most of the spillway discharge channel, bedrock outcrops in numerous and extensive, broken abrupt ribs and knobs between which are boulder-strewn, till-filled troughs. Much of the spillway discharge channel lies within a natural broad gully in the rock which is occupied by a small intermittent stream. On the right abutment the bouldery till blanket, although generally thin, is more continuous than that on the left abutment, and bedrock is exposed within the dam area on the abutment only in and adjacent to the rock cut for the abandoned railroad. On the ridge immediately upstream from the spillway area there are a few bedrock outcrops but within the dike foundation area the rock is buried by till. In the wide, flat saddle closed by the dike, run-off from the adjacent slopes tends to remain in local undrained depressions to create a high water table and keep the area wet during a large part of the year. On the far northern abutment of the dike the ground surface is thickly strewn with boulders probably derived in part from the bedrock outcrops which occur on the slope above the dike area.
